Journal of Rock Mechanics and Geotechnical Engineering

Tests and analysis of mechanical behaviours of rock bolt components for China's coal mine roadways

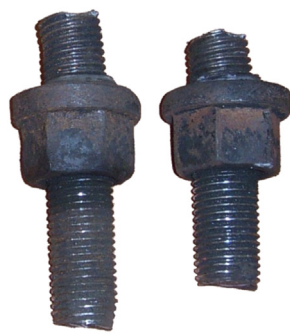
(a) Broken samples.

(b) Intact sample.

Fig. 1. Samples of bolt threads.

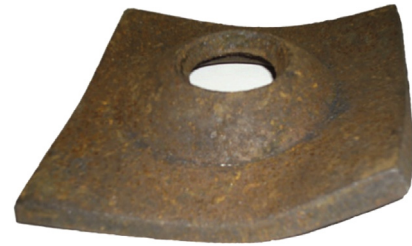
Fig. 2. A sample of severely deformed plate.

The newly developed high strength rock bolts have been widely used in many coal mining districts in China, and large deformation and/or failure of roadways have been effectively controlled (Kang et al., 2009, 2011). However, as the mining depth increases, the geological conditions are becoming more complex, and some challenging issues arise for roadway reinforcement using the high strength rock bolts subsequently. One of the major issues is that some bolts were fractured, as shown in Fig. 1. Fractured bolts will lose their capacity to support surrounding rock mass, as a result cause roof collapse and rib spalling. The bolt accessories such as plates can also suffer serious deformation as shown in Fig. 2, further contributing to decrease in bolting effects.

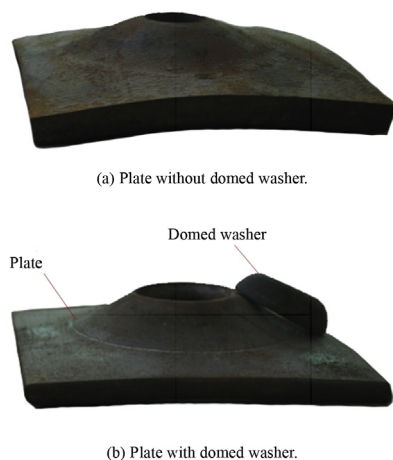
Fig. 15. Two types of plates for tests.

Compression tests were performed on two types of plates to evaluate their bearing capacities, i.e. the plate with and without domed washer as shown in Fig. 15. The domed washer has a major impact on the stress conditions of rock bolt when the bolt is not installed perpendicularly to the plate.

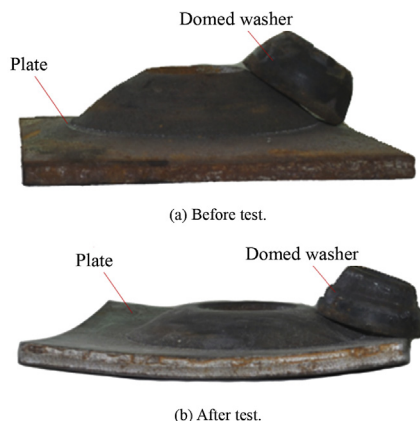
**Fig. 21.** Failure pattern of the plate with domed washer.

stage III, the interior annulus line (A, A' in Fig. 19) on the base of the arch starts to contact the bottom platen; (4) stage IV, the maximum load is reached; and (5) stage V, the arch is flat at compression or the domed washer is pushed to contact the bottom platen. The load and deformation of the plates at different deformation stages are given in Tables 6 and 7, respectively, where P_f is the failure load of plates. Figs. 20 and 21 present the failure patterns of plates without and with domed washer, respectively.
